INVESTIGATION OF THE NORTHWEST AREA OF
ROCKY MOUNTAIN ARSENAL

GEOHYDROLOGY DIVISION
CONTAMINATION CONTROL DIRECTORATE

NOV 78

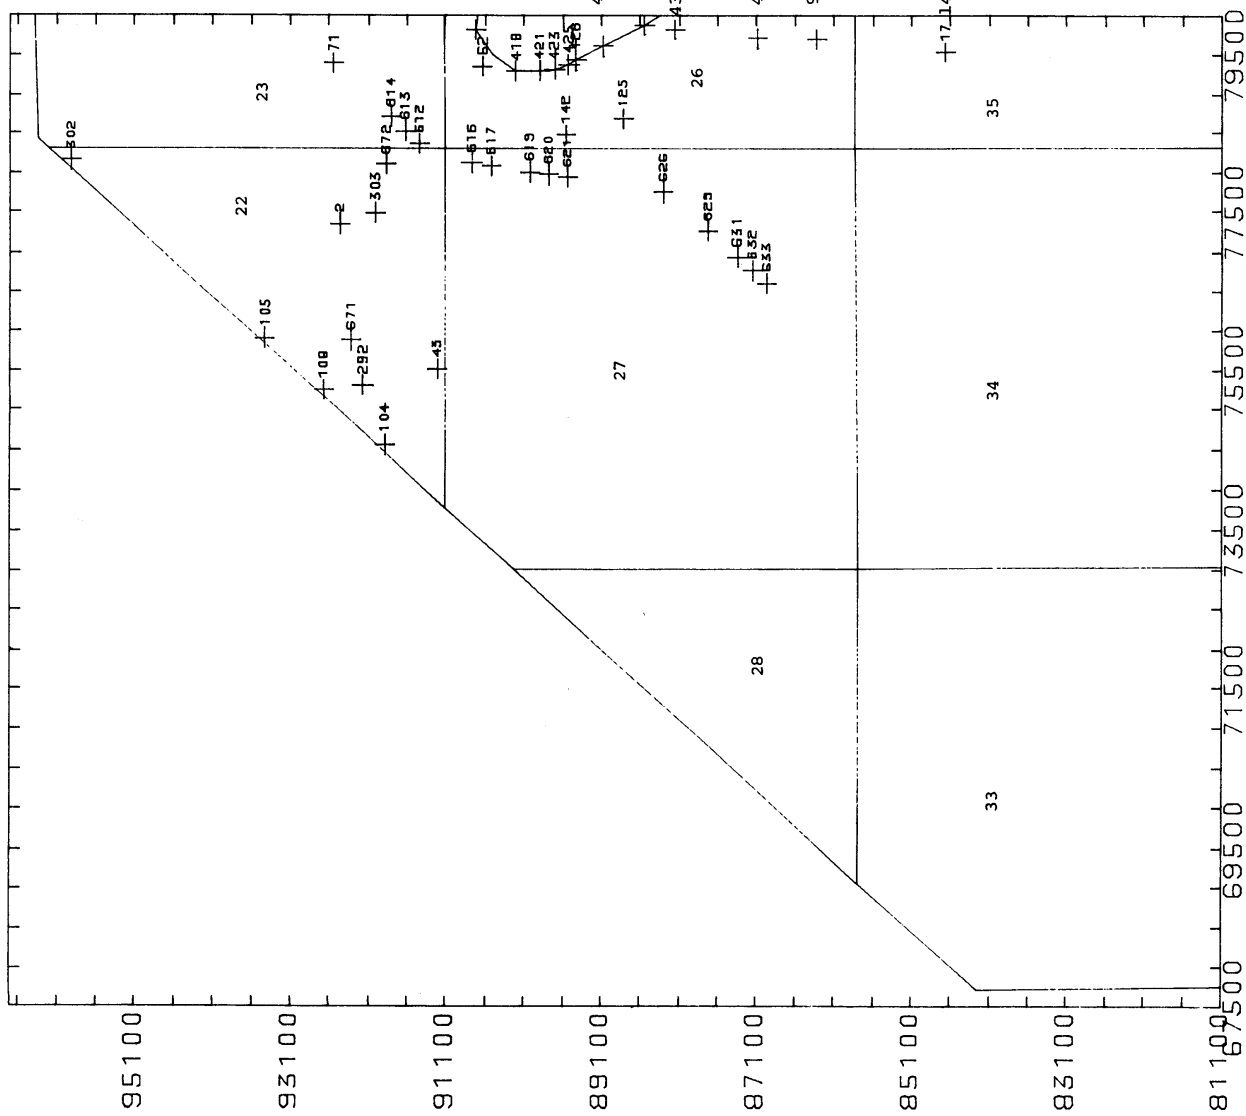
FIGURE 31. LOCATION OF WELLS IN THE
NORTHWEST AREA OF RMA CONTAINING
SIGNIFICANT LEVELS OF FLUORIDE
SCALE: As shown

(4) High fluoride levels were observed throughout the study area (Table 4, Figures 31 and 32). High concentrations were detected in wells adjacent to the Arsenal boundary in Section 22. The quantity of water moving off post in the portion of the area having significant water flow was calculated using the

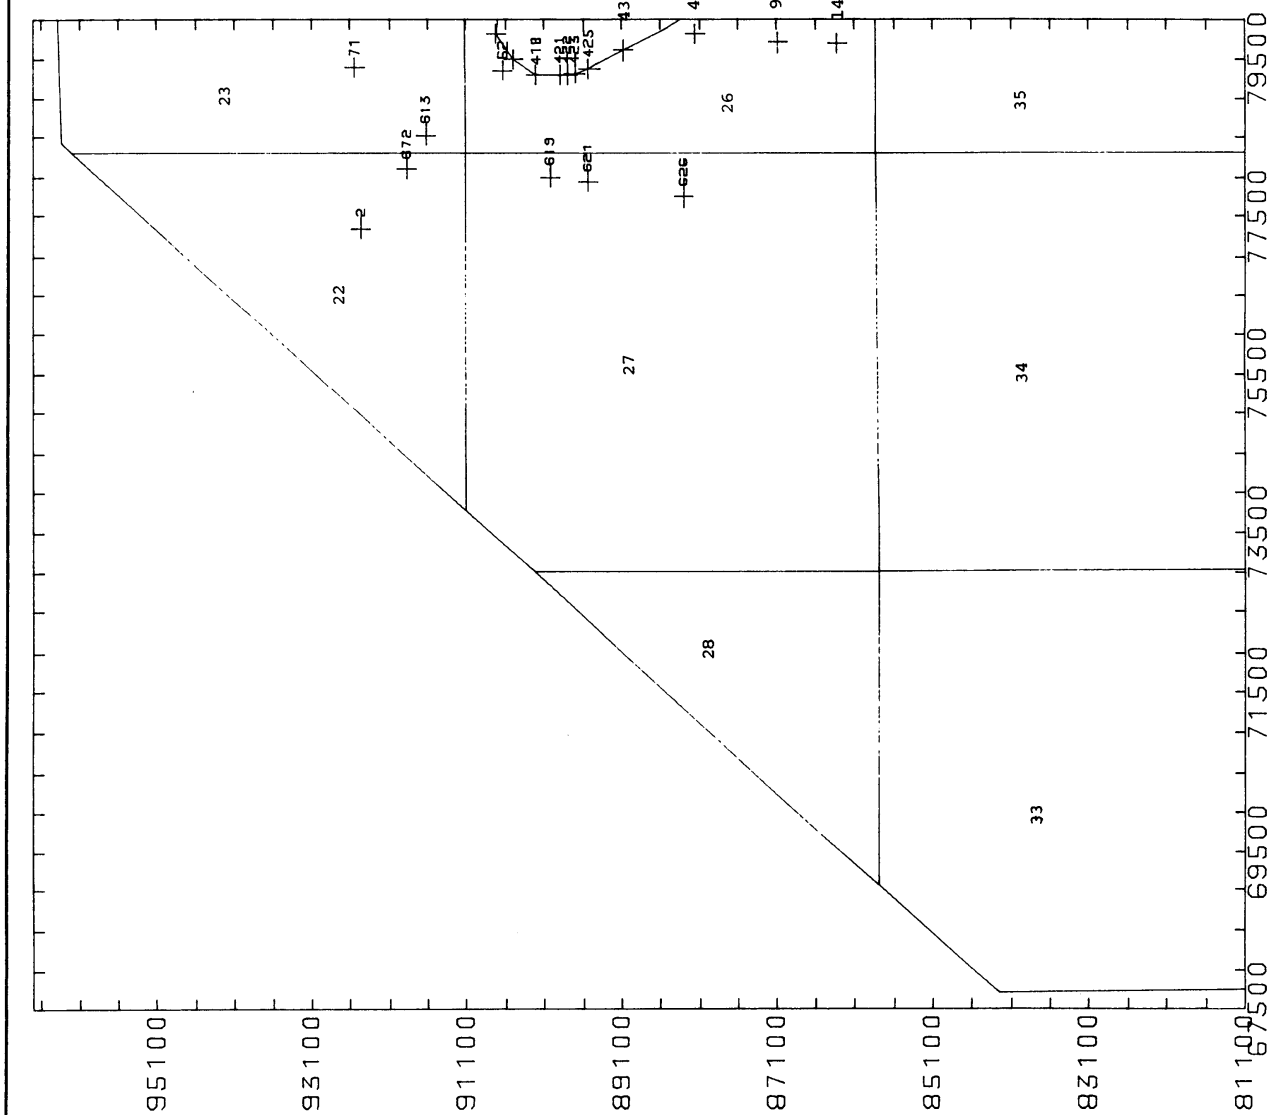
FIGURE 33. LOCATION OF WELLS IN THE
NORTHWEST AREA OF RMA CONTAINING
SIGNIFICANT LEVELS OF DIMP.

(5) High DIMP levels were detected at the edge of Basin F and in an area extending northwest from the northwest corner of that Basin (Table 4, Figures 33 and 34). Few high DIMP values were observed along the E-E' line. Well 27-23 had the highest value, but this sample was recovered from a hole drilled deeply into bedrock. This may be an accurate value or result from a concentration artifact as seepage into the hole evaporates. This well can only be sampled when long-time periods pass between sampling efforts to allow water build up. DIMP was observed along the northwest boundary, but at only extremely low levels.

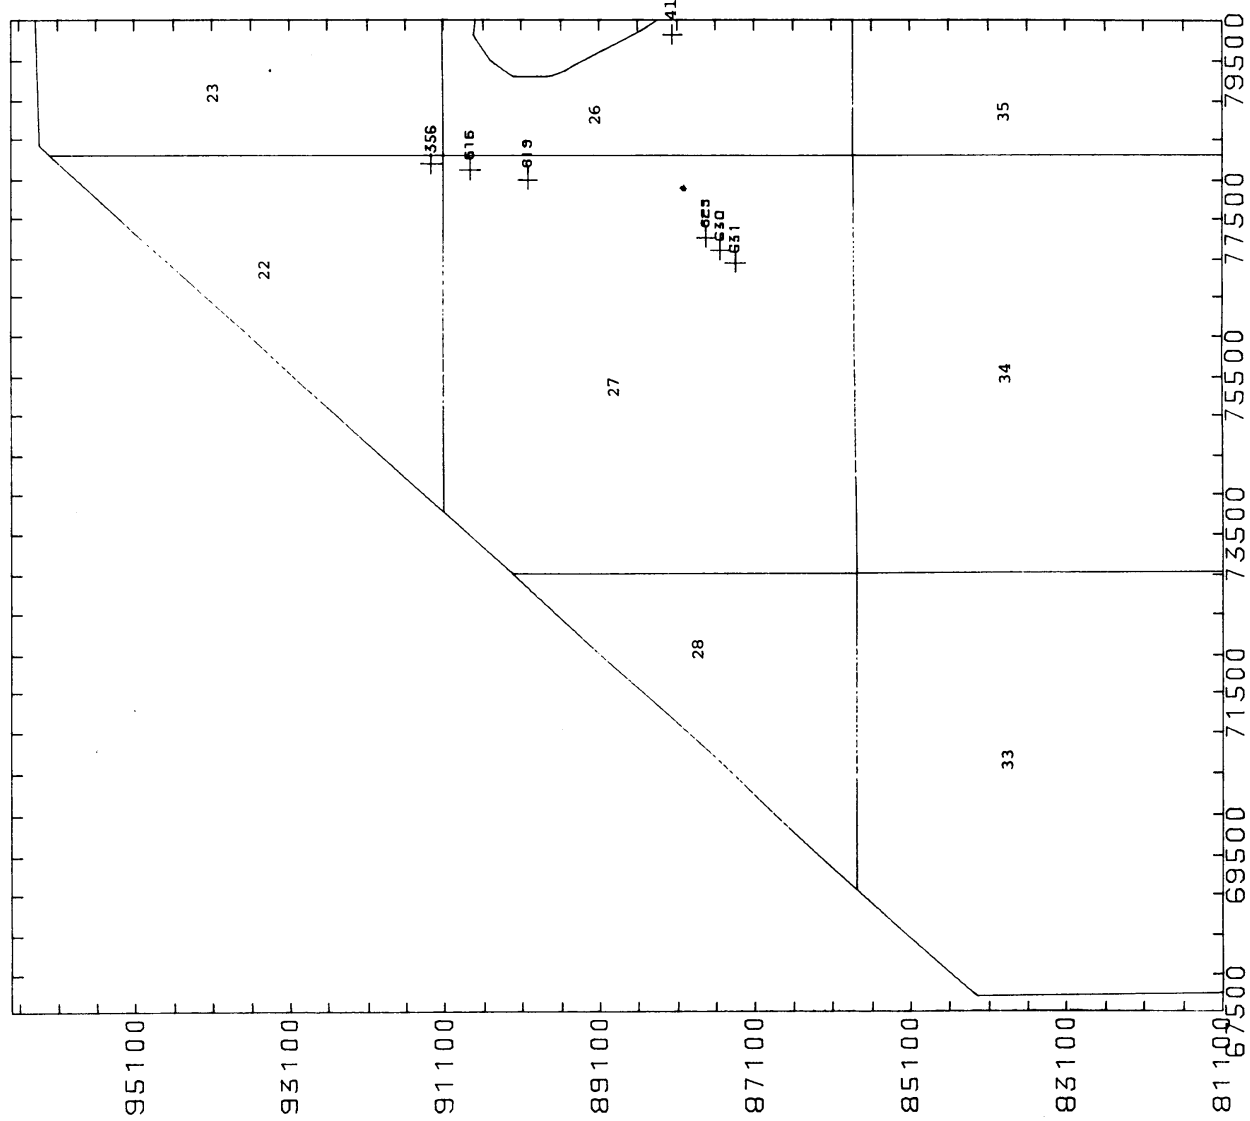
FIGURE 35. LOCATION OF WELLS IN THE NORTHWEST AREA OF RMA IN WHICH DCPD WAS DETECTED.

(6) DCPD was very rarely observed (Table 4 and Figure 35), essentially only along the E-E' line. It was also normally only observed on the first analysis. Most of the positive results were obtained when the standard was later determined to be defective. DCPD, however, was detected when the standards were correct. The most recent sampling was negative.

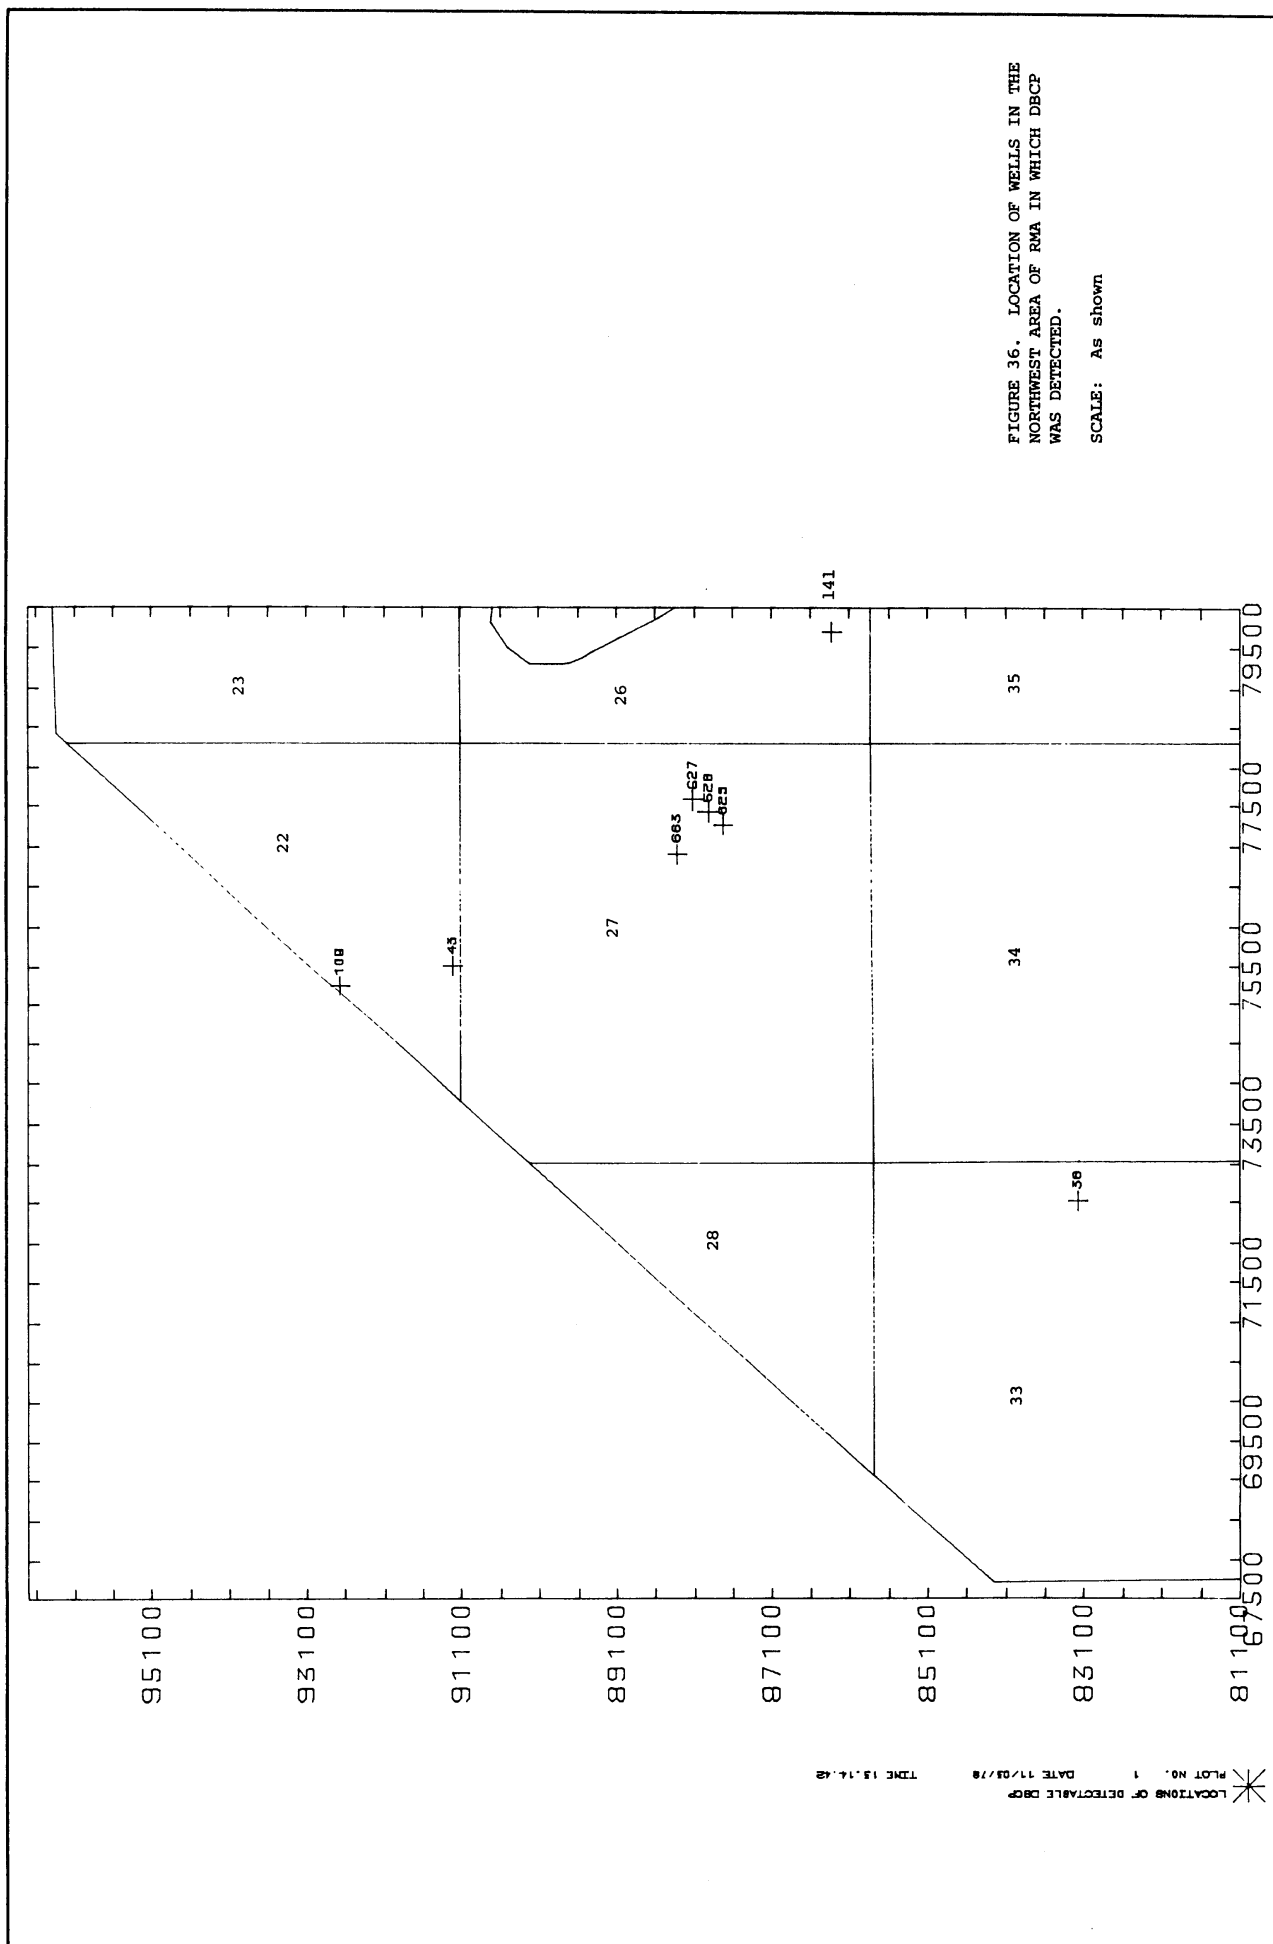
FIGURE 36. LOCATION OF WELLS IN THE
 NORTHWEST AREA OF RMA IN WHICH DBCP
 WAS DETECTED.
 SCALE: As shown

(7) Nemagon was observed at several sampling sites (Table 4 and Figure 36) in very small amounts. Wells in Sections 22, 26, 27, and 33 contained DBCP.
